OMAP-L138 SOM-M1 Errata

Hardware Documentation

Logic PD // Products
Published: April 2010
Last revised: June 2014

This document contains errata information for the OMAP-L138 SOM-M1 and TMS320C6748 SOM-M1.

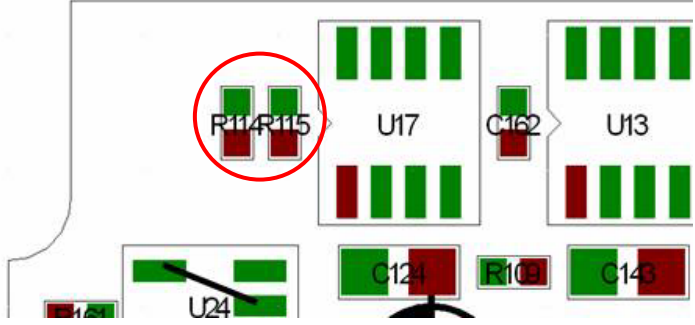
Errata ID	Summary	Details
<p>E0013</p> <p>FIXED</p>	<p>Title: INA219 pull-up resistors too strong</p> <p>Affected Part Number(s): 1014650, 1014651, 1014652, 1014613</p> <p>Release Date: 04/01/10</p> <p>Resolution Date: 09/29/10</p>	<p>Description: Communication with the INA219 may not function properly because the 1k ohm resistors are too strong.</p> <p>Work Around: Replace resistors R114 and R115 with 4.7k ohm resistors. See image below for resistor location. IMPORTANT NOTE: Any modification of the SOM voids warranty.</p>

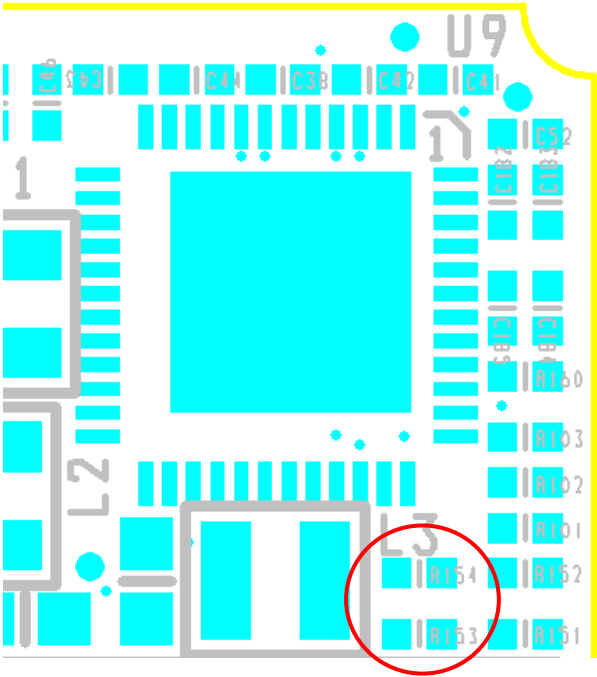
<p>Fix Plan/Status: This issue has been resolved as of PCN 450.</p>
<p>E0014</p> <p>FIXED</p>	<p>Title: USB data line pull-down resistors</p> <p>Affected Part Number(s): 1014650, 1014651, 1014652, 1014613</p> <p>Release Date: 04/01/10</p> <p>Resolution Date: 09/29/10</p>	<p>Description: External resistors were added to the USB data line that duplicate internal resistors. USB use is not impacted by this issue, but the addition of external resistors does not follow the USB specification.</p> <p>Work Around: Remove resistors R153 and R154. See image below for resistor location. IMPORTANT NOTE: Any modification of the SOM voids warranty.</p>

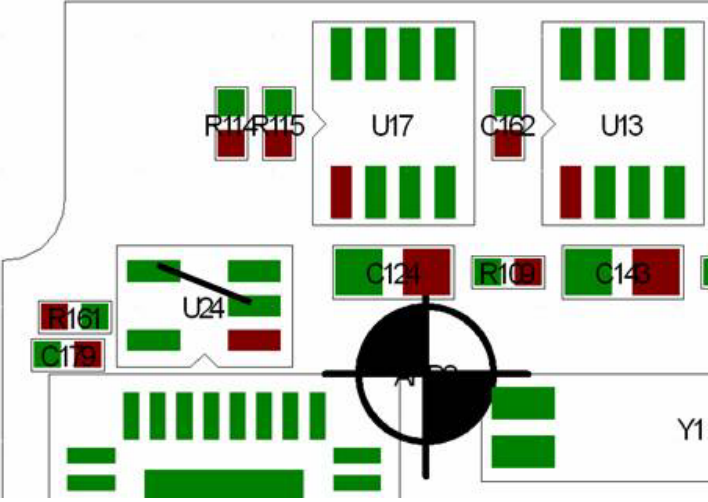
Errata ID	Summary	Details
<p>E0019</p> <p>FIXED</p>	<p>Title: Communication issues with I2C interface on PMIC</p> <p>Affected Part Number(s): 1014650, 1014651, 1014652, 1014613</p> <p>Release Date: 04/01/10</p> <p>Resolution Date: 09/29/10</p>	<p>Description: The I2C interface on TPS65070 may experience communication issues because buffer U24 only allows unidirectional communication.</p> <p>Work Around: If you are experiencing communication issues with the PMIC I2C interface and this communication is essential to your development efforts, the following rework instructions may be used. IMPORTANT NOTE: Any modification of the SOM voids warranty.</p> <p>Remove U24 Remove R161 Jumper U24.2 to U24.4 using a bare piece of 30 AWG wire (as shown below)</p>
